BOROUGH OF AKRON

EVALUATION OF REHABILITATION OF THE 80,000-GALLON STANDPIPE TANK VS. NEW ELEVATED PEDESPHERE TANK

Project No. 4699.001

Dated: July 15, 2024

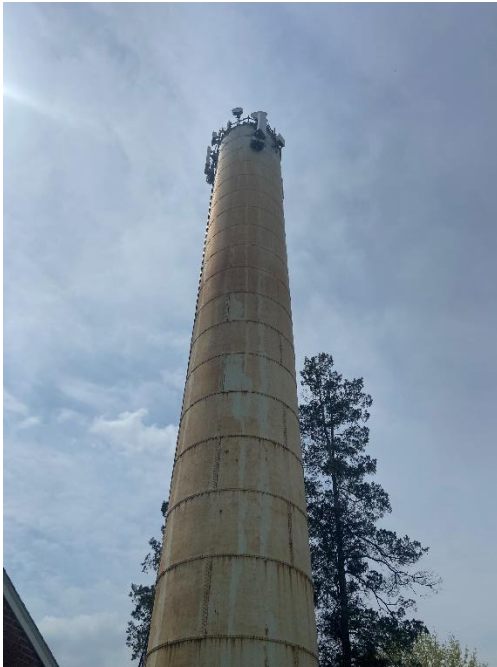
Standpipe with antenna and tree that will need removal.

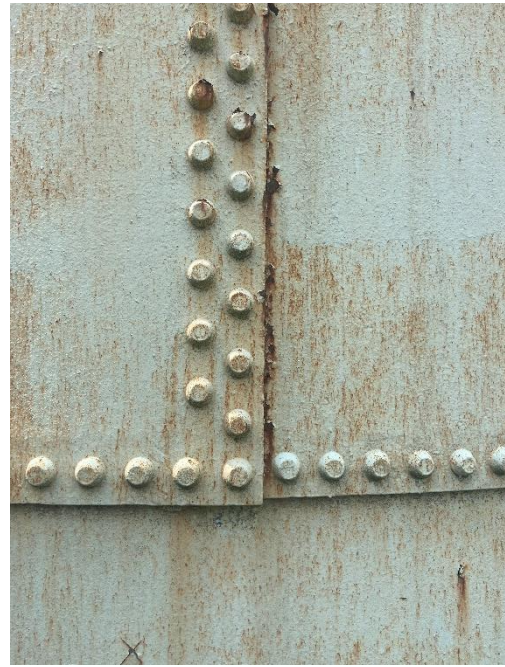
Sidewall plates and rivets showing corrosion.

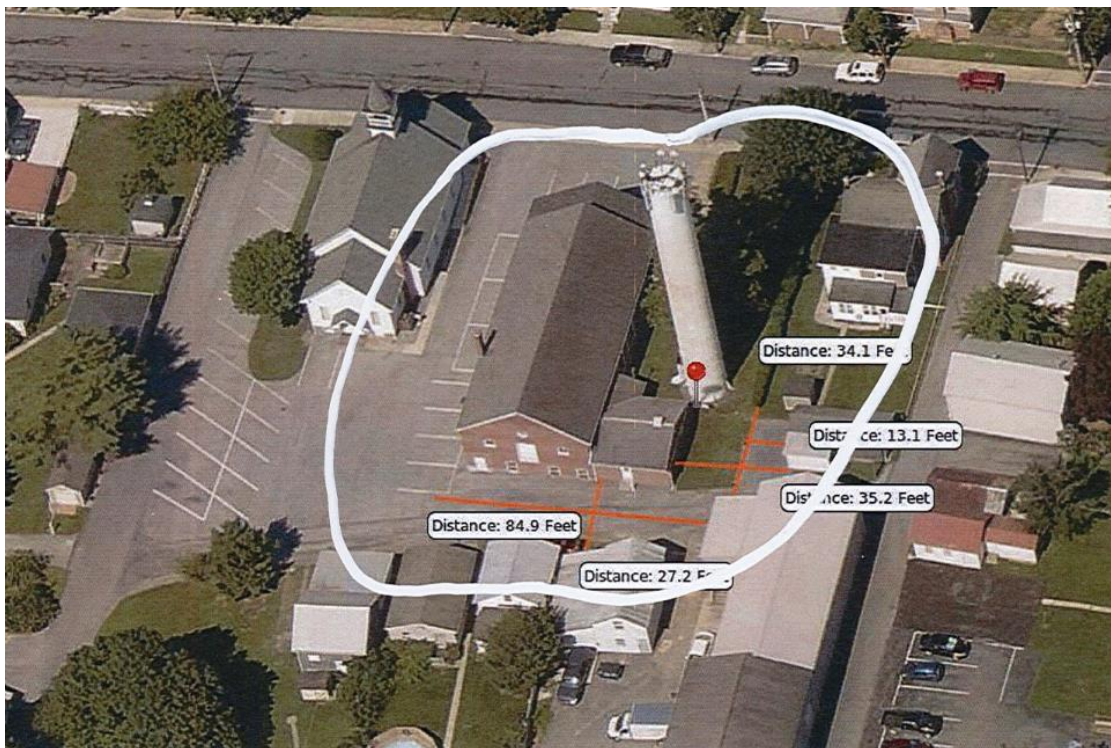
White circle indicates area where fire blankets will need to be placed on the rooftops.

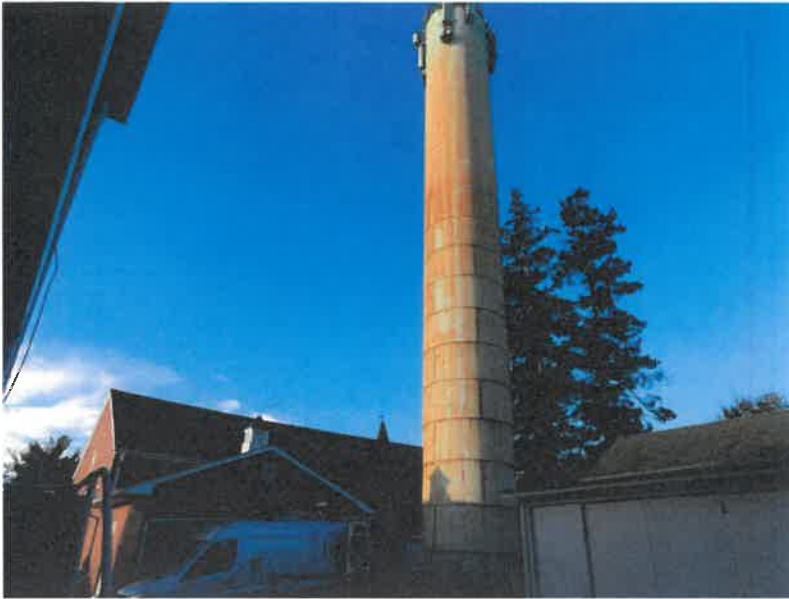
Photo # 1

1. Site - The tank site is confined. The site is generally flat and grassy, with asphalt present around the tank foundation. Hedges, private residences, a church, cell carrier buildings, the cabinet above the valve vault, and small trees occupy the area further out from the tank. There is limited laydown area for the Contractor's equipment during the tank rehabilitation, it is likely that easements and temporary fencing will be required. See photographs #1-#8.

Generalized pinhole corrosion was present on 90% the shell. Isolated areas of coating breakdown with corrosion and stone bruising were noted on the lower shell plates, as well as on irregular surfaces such as along the riveted seams, shell ladder, shell manhole, name plate, and anchor bolt wing plates. See photographs #1, #9, and #18-#47.

Grounds around tank.

It is our recommendation that the exterior surfaces are abrasive blasted in one (1) to two (2) years. It will be necessary to maintain a Class 1A Containment system in accordance with SSPC Guide 6 during abrasive blasting and coating operations to prevent fugitive dust and emissions from escaping the work area. We have attached our Cost Estimate Sheet, as well as our Cleaning and Painting Recommendation Sheet, for your review and consideration.

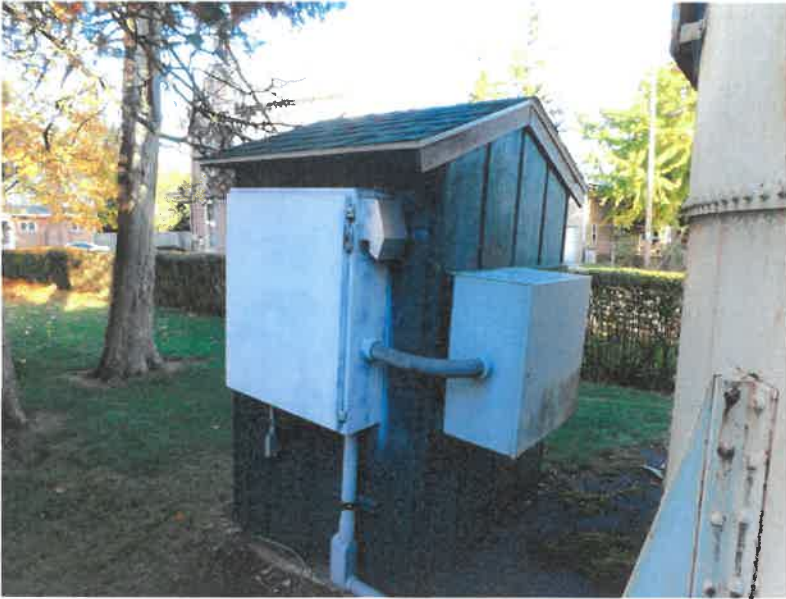
Photo # 10

a. Valve Vault - Access to the valve vault is provided by the locked cabinet on site. The piping in the vault was exhibiting 100% surface corrosion. Pitting was present on one (1) of the ductile iron spans. We recommend that the pipe span exhibiting heavy corrosion and pitting is replaced. The existing pipes in the pump house should be cleaned to an SSPC-SP6, "Commercial Blast" and recoated during the tank rehabilitation. See photographs #10-#17.

Piping in vault.

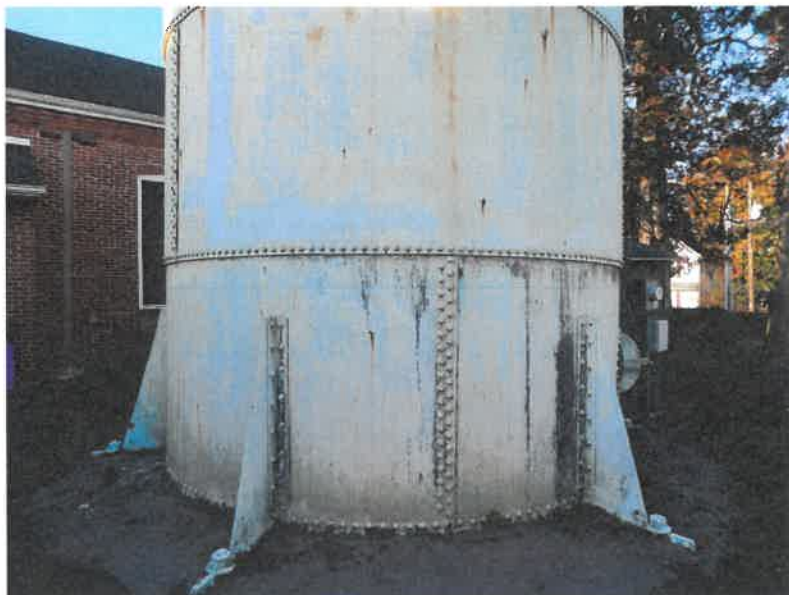
Photo # 18

2. Foundation - The exterior foundation is buried and has been capped with asphalt. Its condition is unknown. Minor vegetative growth was present at the shell to asphalt interface. See photographs #18-#21.

Foundation, wing plates, anchor bolts, and coating on shell.

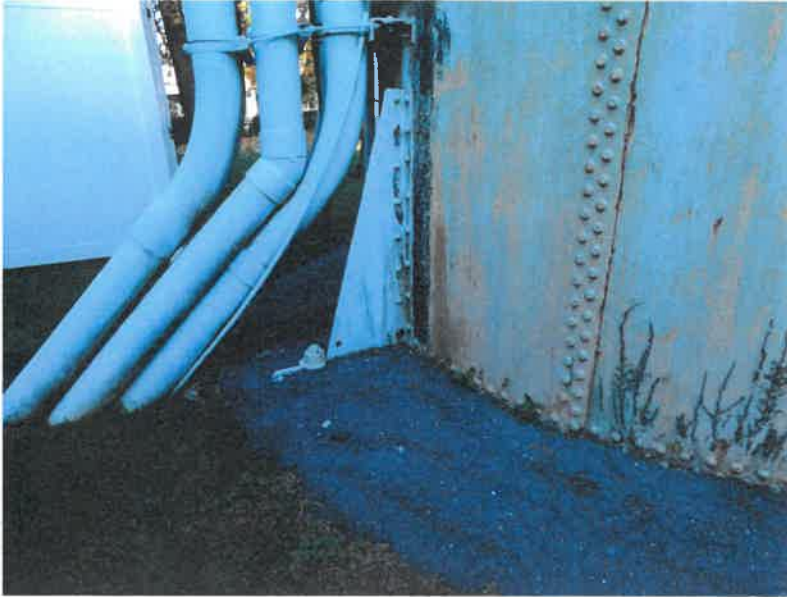
Photo # 19

c. Anchor Bolts - There are a total of six (6) 1-3/4" diameter anchor bolts. Only the tops of the anchor bolts were exposed. The coating on the anchor bolt nuts were found to be in good condition with only minor pinhole corrosion noted. See photographs #19-#21.

Foundation, wing plate, and anchor bolt.

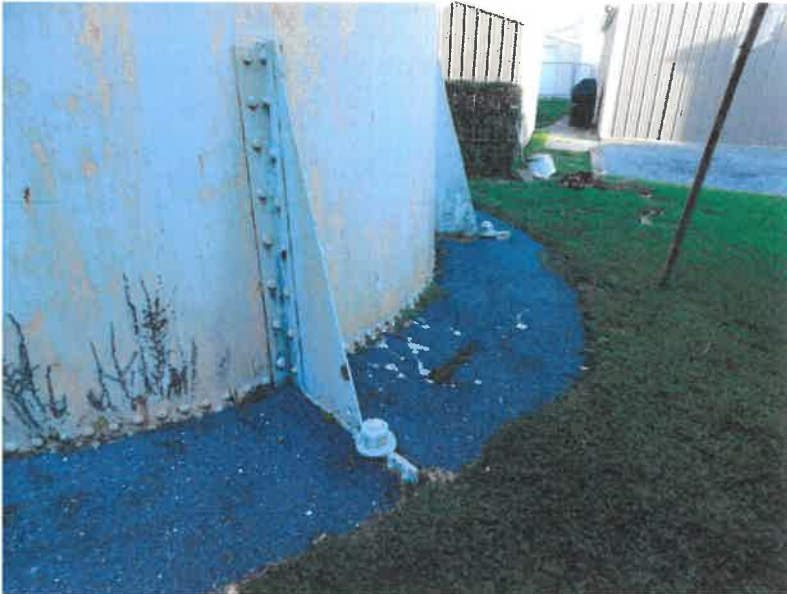
Photo # 20

Foundation, wing plates, and anchor bolts.

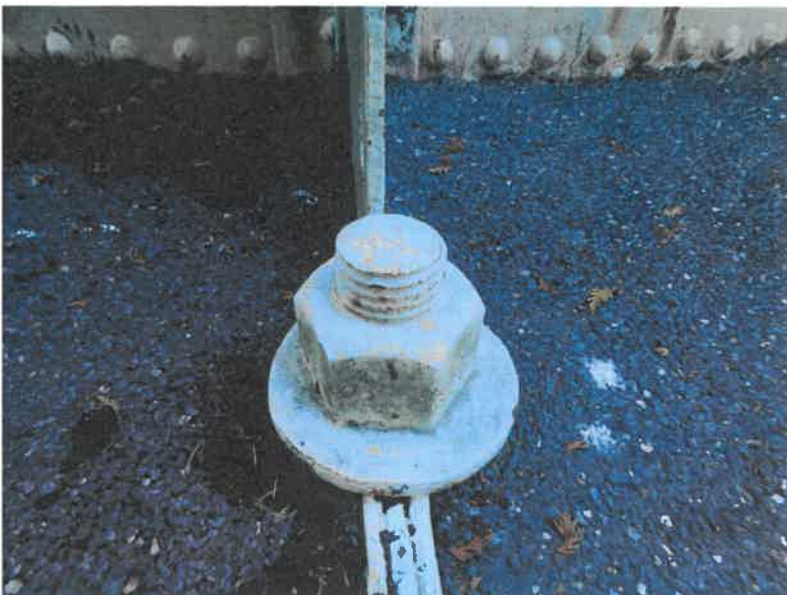
Photo # 21

Foundation, wing plate, and anchor bolts.

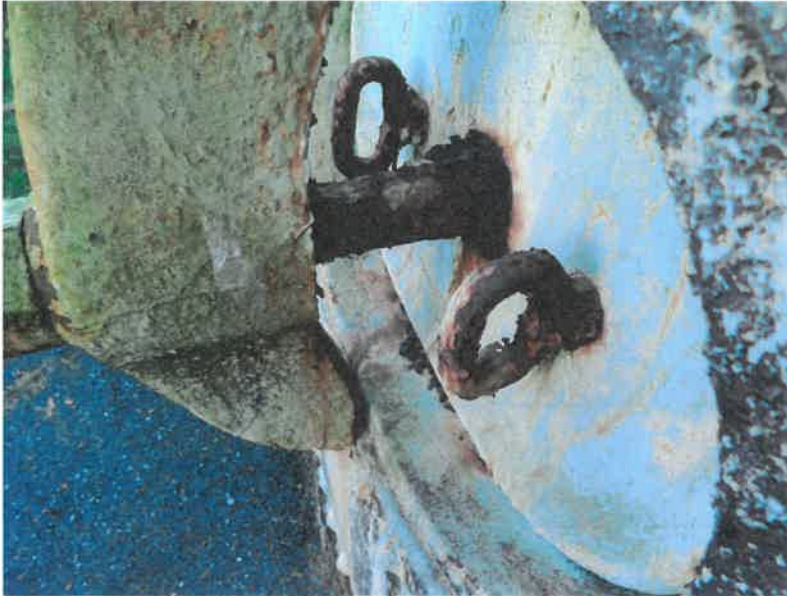
Photo # 37

d. Shell Manhole - This tank is equipped with a single 14" x 20" shell manhole located 24" above grade. The manhole is equipped with a single clamp. Coating breakdown with corrosion was present on the manhole bolt and minor pinhole corrosion was present on the lid. Currently, AWWA recommends that standpipes are equipped with two (2) shell manholes, and that at least one shell manhole measure 30" diameter to aid in entry and egress. See photographs #36 and #37.

Corrosion on bolt connecting 14" x 20" shell manhole to cross clamp.

c. Replace existing shell manhole with a new bolted 30" diameter shell manhole, with external hinge or davit arm. See attached drawing.

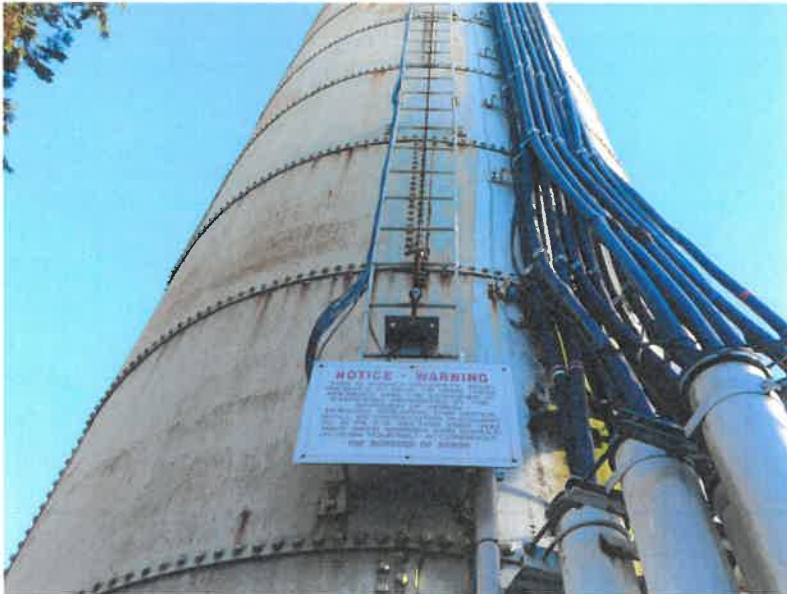
Photo # 38

e. Shell Ladder - The 12" clear rung width (CRW) shell ladder is equipped with a 7" standoff and begins 8' above grade. A galvanized flexible cable safety climb device was present. Pinhole corrosion was present on the shell ladder. The dimensions of the shell ladder do not conform with OSHA's 29 CFR 1910.27, which requires that ladders measure no less than 16" CRW. See photographs #38-#40.

12" CRW shell ladder with flexible cable safety climb, and T-Mobile coaxial cable run.

d. Replace existing shell ladder with an OSHA compliant ladder. See attached drawing.

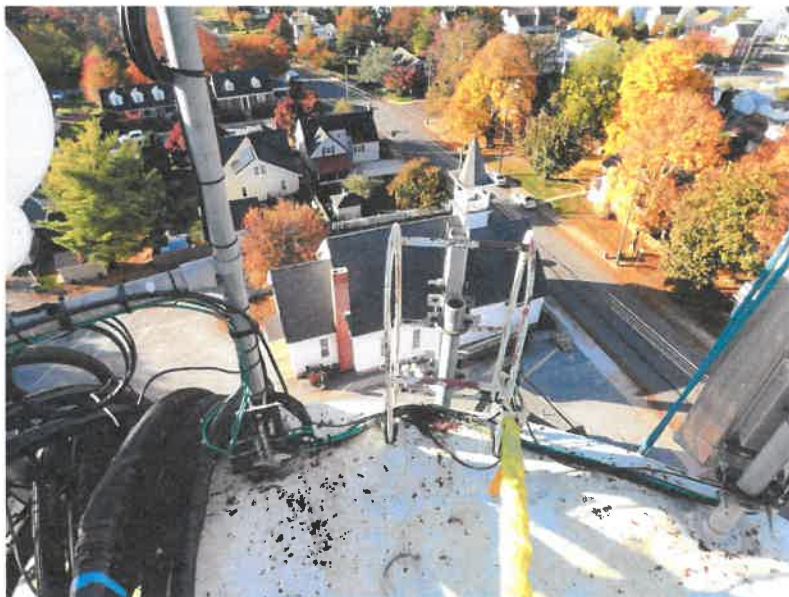
Photo # 48

The coating on the roof was heavily weathered and exhibiting sporadic areas of pinhole corrosion, affecting nearly 30% of the roof. Isolated coating breakdown with corrosion was also noted on the roof manhole. Heavy debris and fallout staining were present on the roof. Open holes were present at the shell to roof junction. See photographs #48-#63.

Shell ladder transition to roof.

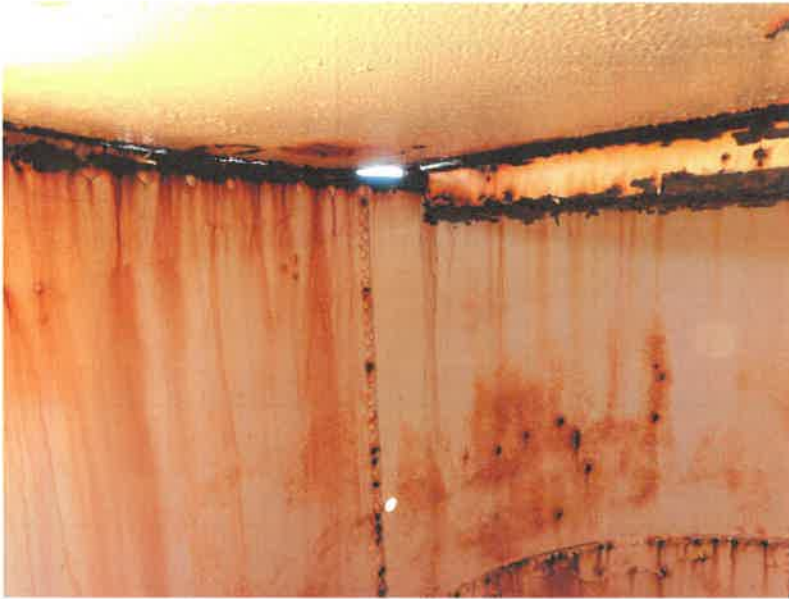
Photo # 64

Generalized pinhole corrosion and isolated areas of coating breakdown with corrosion were present on shell plates. Coating breakdown with corrosion was observed on irregular surfaces such as roof rafters, lap seams, and shell fasteners. A gap was present between the shell and the roof. See photographs #64-#75, and ROV footage.

a. Roof Rafters - The I-beam cross brace roof rafters were found to be in poor condition with generalized coating breakdown with corrosion present on the flanges. Visible metal loss was observed on the rafter flanges and bolted connections. See photographs #64-#66 and #69.

Coating on interior roof, shell, and rafter.

a. Total replacement of the roof, including the rafters, should be anticipated during the next rehabilitation.

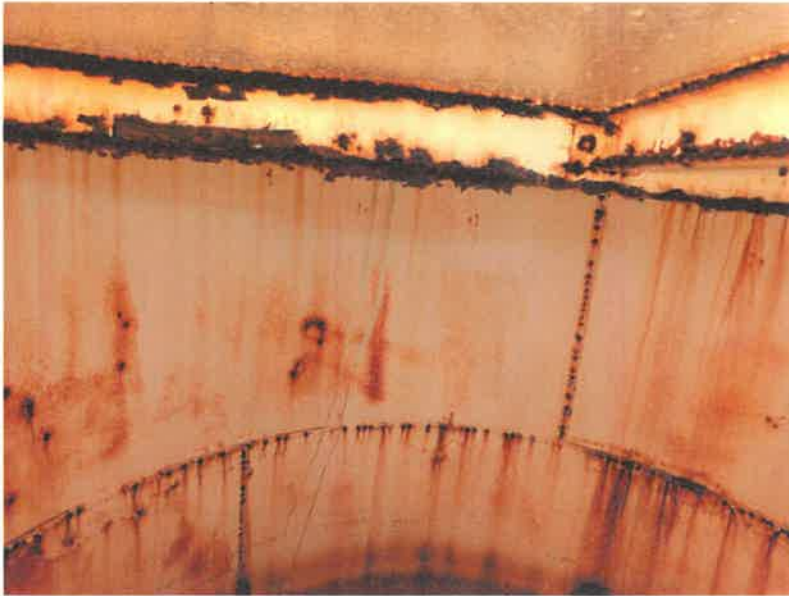
Photo # 65

Coating on interior roof, shell, and rafters.

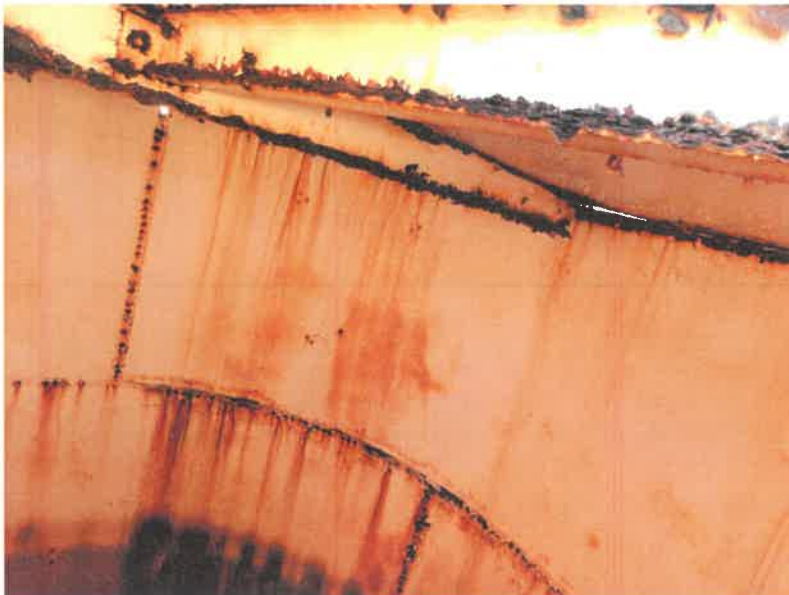
Photo # 66

Coating on interior roof, shell, and rafters.
