BOROUGH OF AKRON

EVALUATION OF REHABILITATION OF THE 80,000-GALLON STANDPIPE TANK VS. NEW ELEVATED PEDESPHERE TANK

Project No. 4699.001

Dated: July 15, 2024

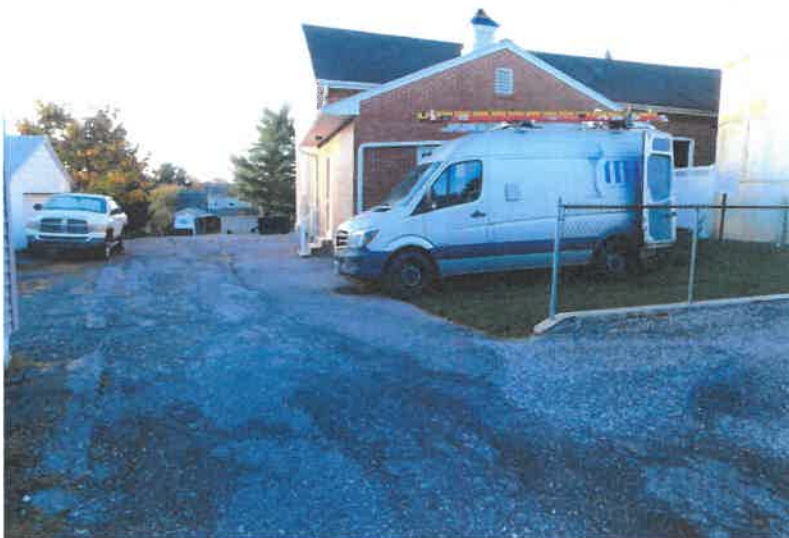
Photo # 2

1. Site - The tank site is confined. The site is generally flat and grassy, with asphalt present around the tank foundation. Hedges, private residences, a church, cell carrier buildings, the cabinet above the valve vault, and small trees occupy the area further out from the tank. There is limited laydown area for the Contractor's equipment during the tank rehabilitation, it is likely that easements and temporary fencing will be required. See photographs #1-#8.

Grounds around tank.

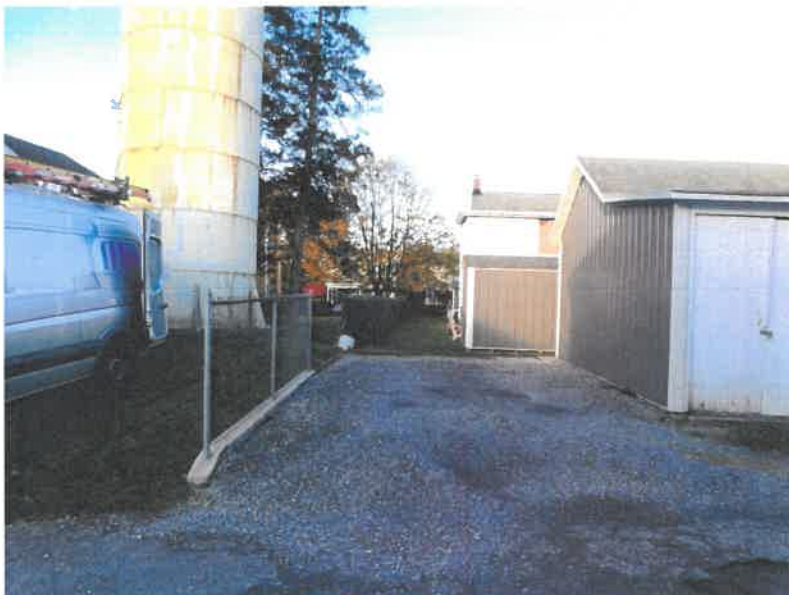
Photo # 3

Grounds around tank.

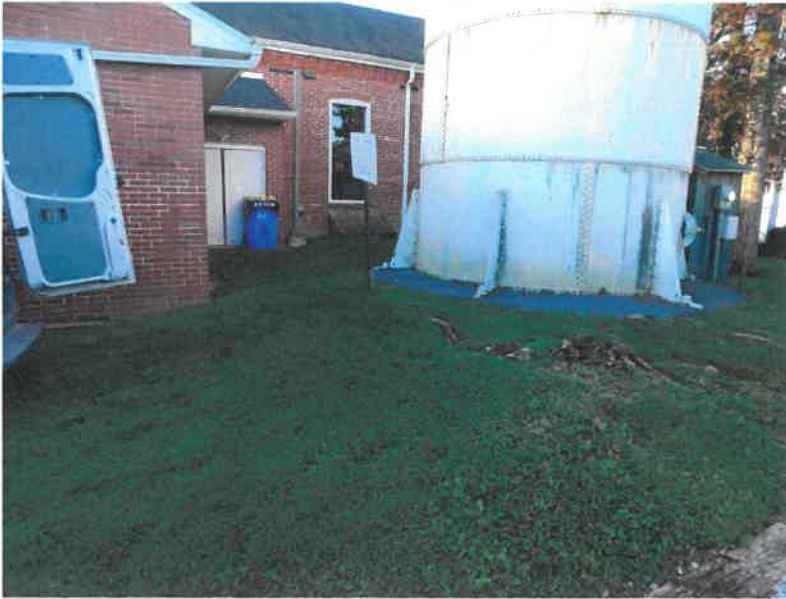
Photo # 4

Grounds around tank.

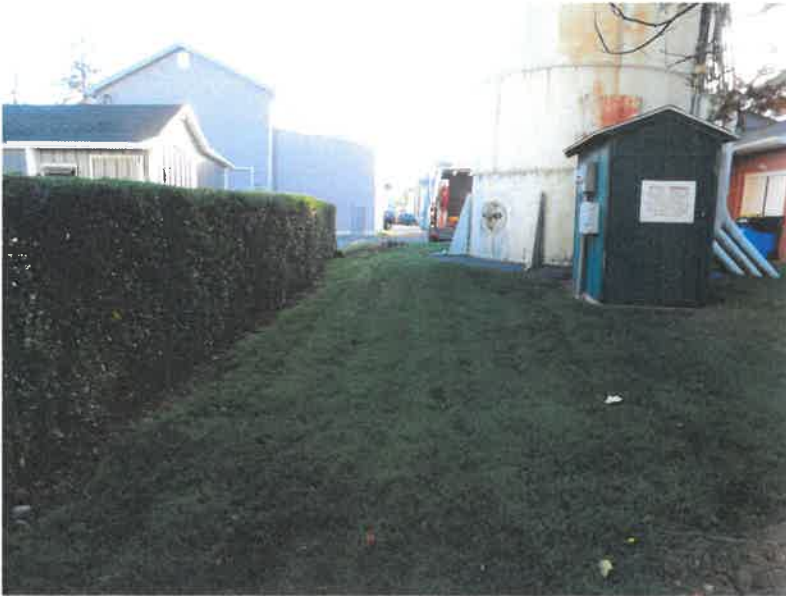
Photo # 5

Grounds around tank.

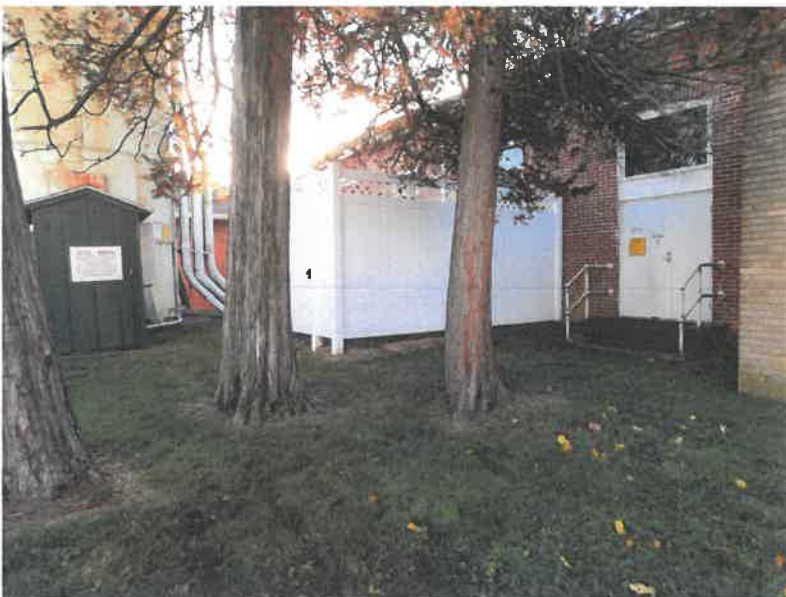
Photo # 6

Grounds around tank.

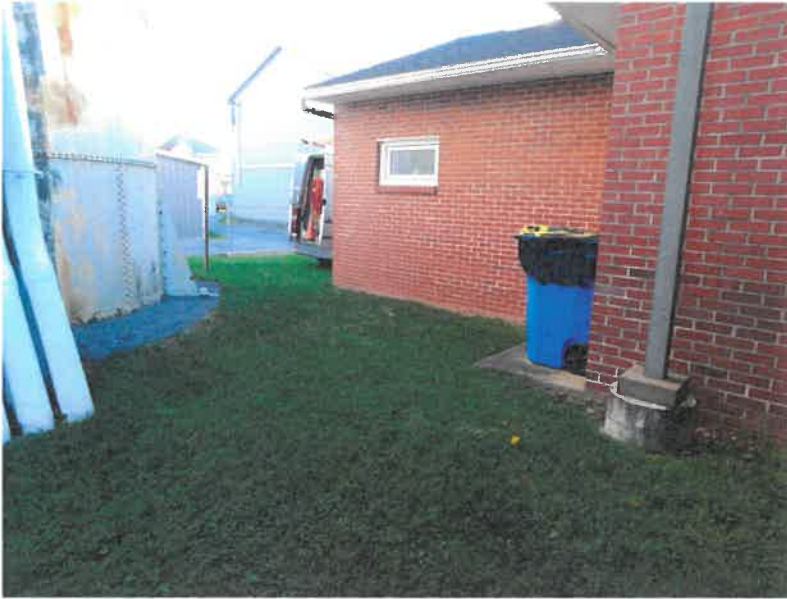
Photo # 7

Grounds around tank.

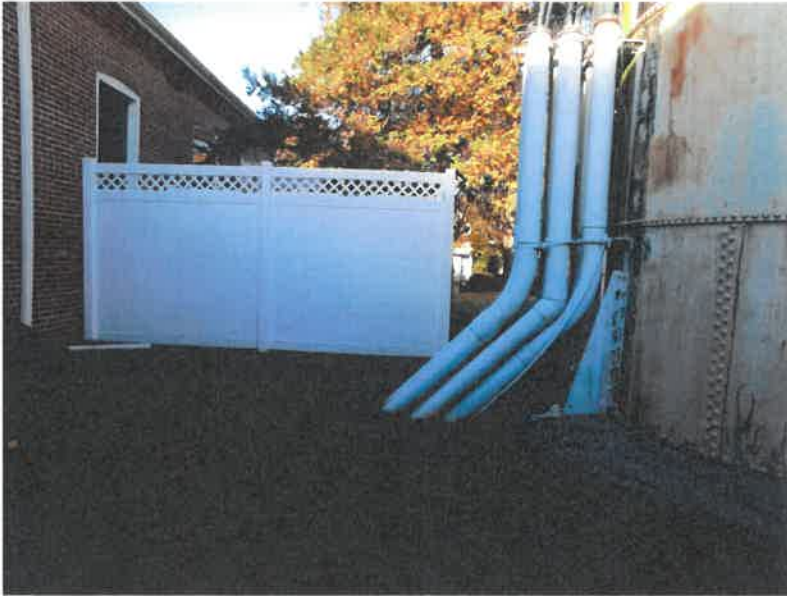
Photo # 8

h. Antennas - T-Mobile occupies space on this tank at the top of the shell. There are two (2) sectors of two (2) T-Mobile antennas mounted on stud welded brackets. An antenna array made up of 2" diameter galvanized pipe is fillet welded to the roof. There are five (5) dish antennas and three (3) sectors of two (2) internet panel antennas mounted on the array. See photographs #8, #9, #19, #38, #39, #41-#47, #49-#52, and #54-#58.

Grounds around tank.

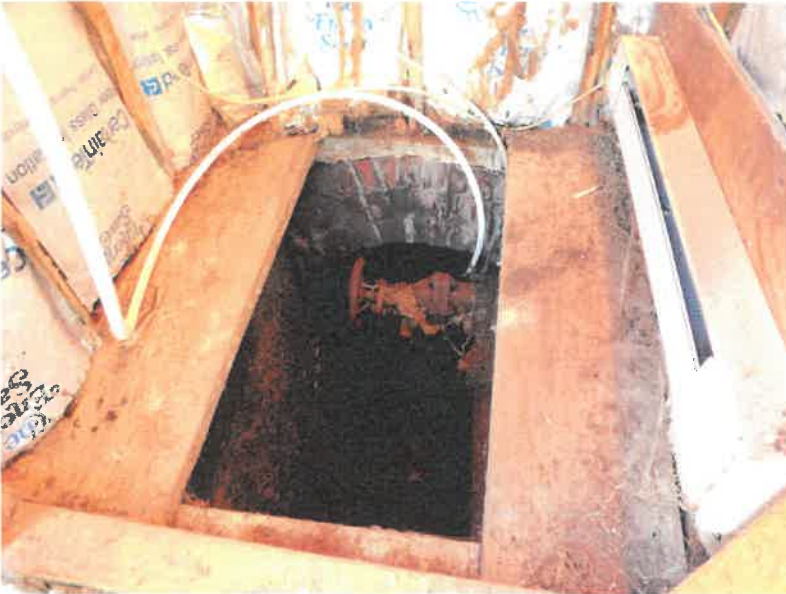
Photo # 12

a. Valve Vault - Access to the valve vault is provided by the locked cabinet on site. The piping in the vault was exhibiting 100% surface corrosion. Pitting was present on one (1) of the ductile iron spans. We recommend that the pipe span exhibiting heavy corrosion and pitting is replaced. The existing pipes in the pump house should be cleaned to an SSPC-SP6, "Commercial Blast" and recoated during the tank rehabilitation. See photographs #10-#17.

Piping in vault.

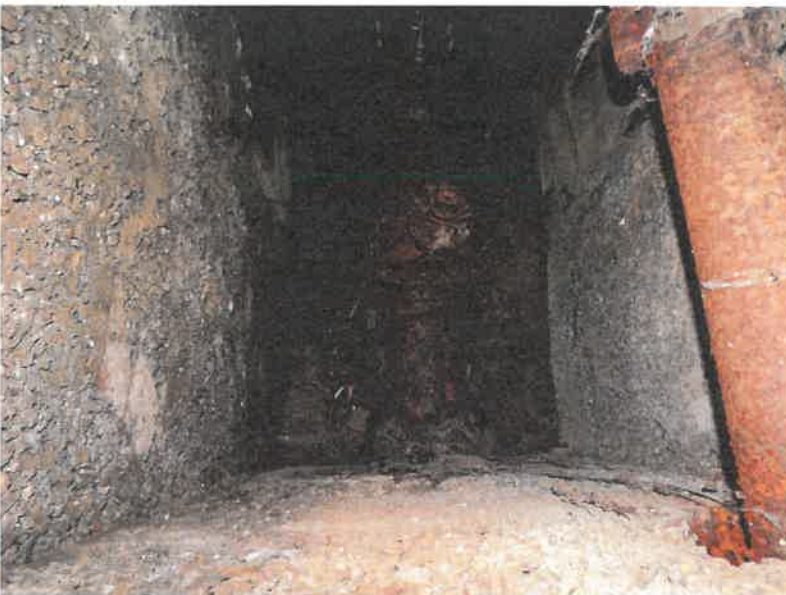
Photo # 13

Piping in vault.

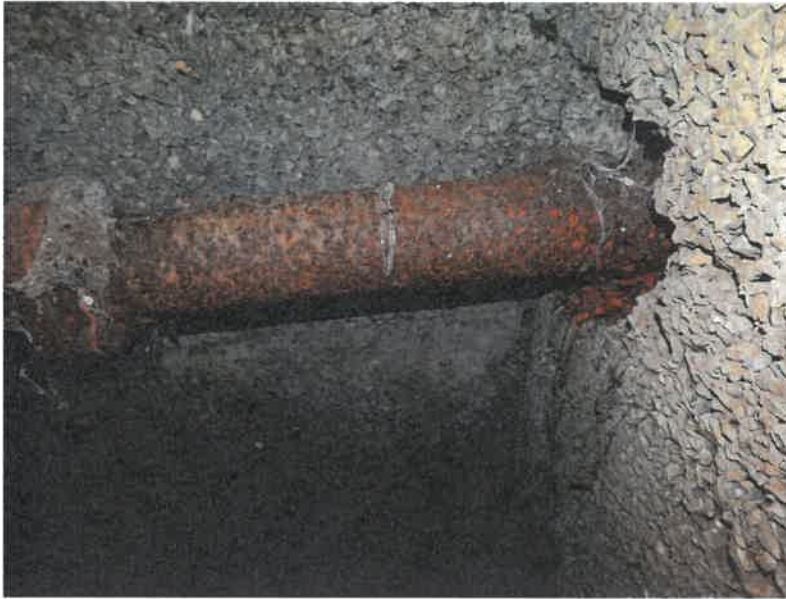
Photo # 14

Piping in vault.

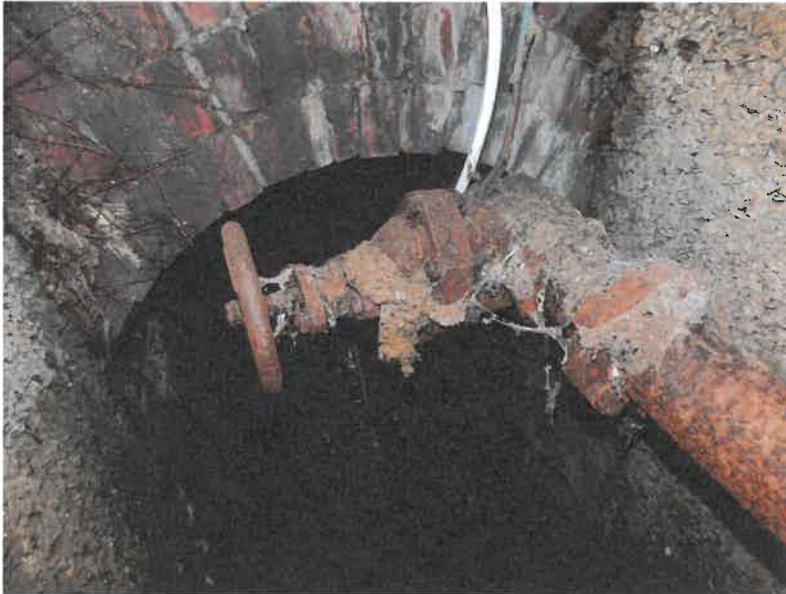
Photo # 15

Piping in vault.

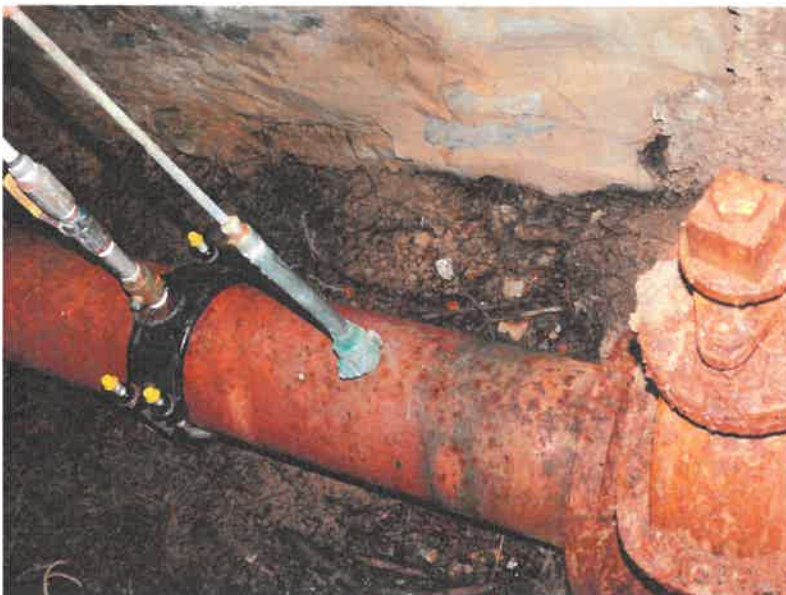
Photo # 16

Piping in vault.

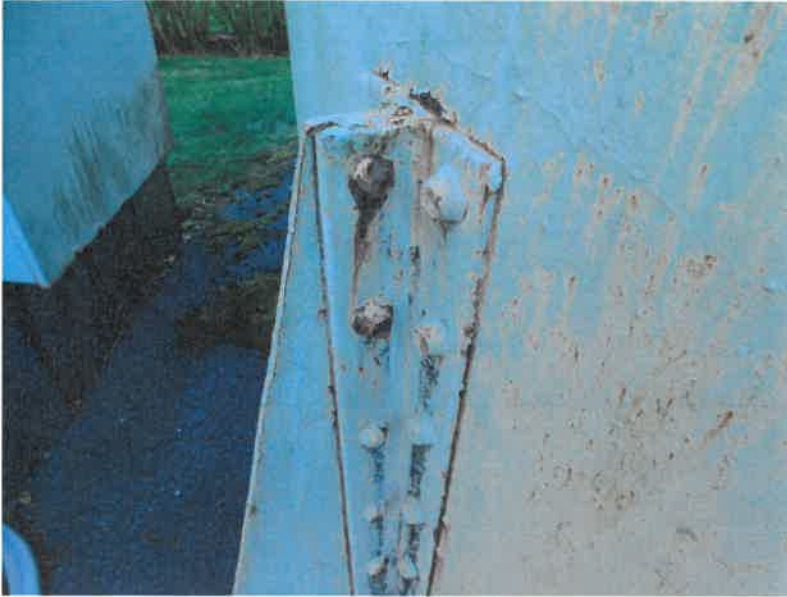
Photo # 23

Generalized pinhole corrosion was present on 90% the shell. Isolated areas of coating breakdown with corrosion and stone bruising were noted on the lower shell plates, as well as on irregular surfaces such as along the riveted seams, shell ladder, shell manhole, name plate, and anchor bolt wing plates. See photographs #1, #9, and #18-#47.

Wing plate attached to shell.

It is our recommendation that the exterior surfaces are abrasive blasted in one (1) to two (2) years. It will be necessary to maintain a Class 1A Containment system in accordance with SSPC Guide 6 during abrasive blasting and coating operations to prevent fugitive dust and emissions from escaping the work area. We have attached our Cost Estimate Sheet, as well as our Cleaning and Painting Recommendation Sheet, for your review and consideration.

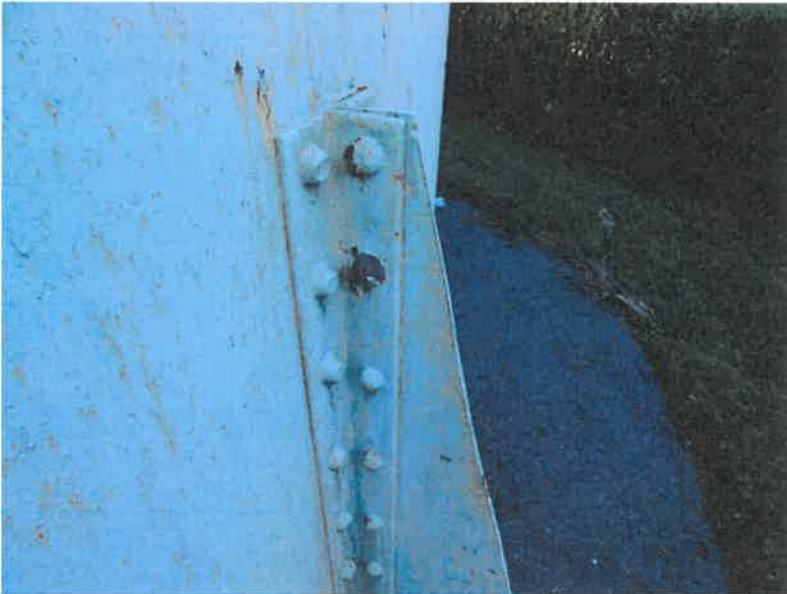
Photo # 24

Coating on shell.

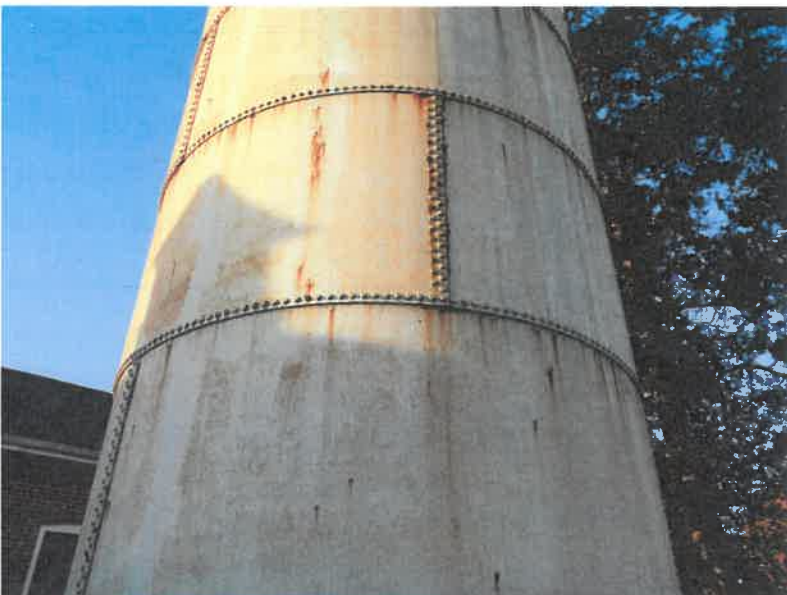
Photo # 25

Coating on shell.

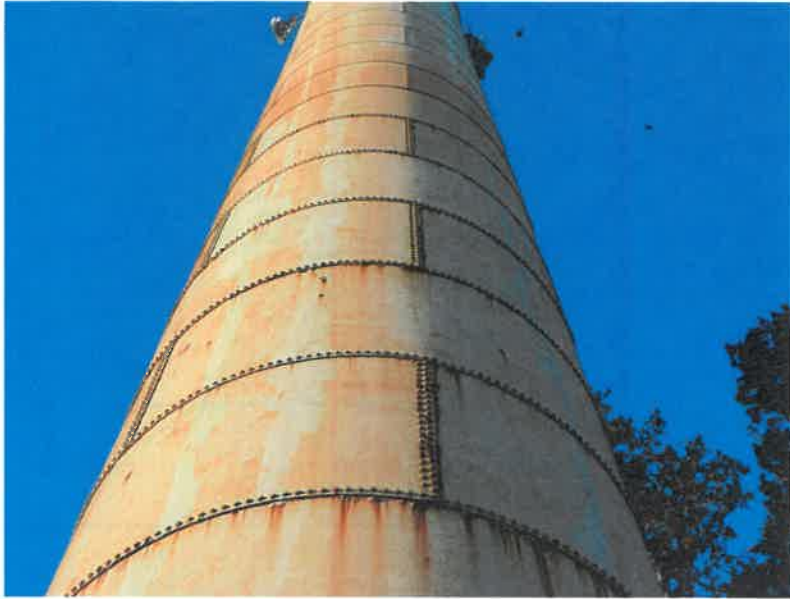
Photo # 26

Coating on shell.

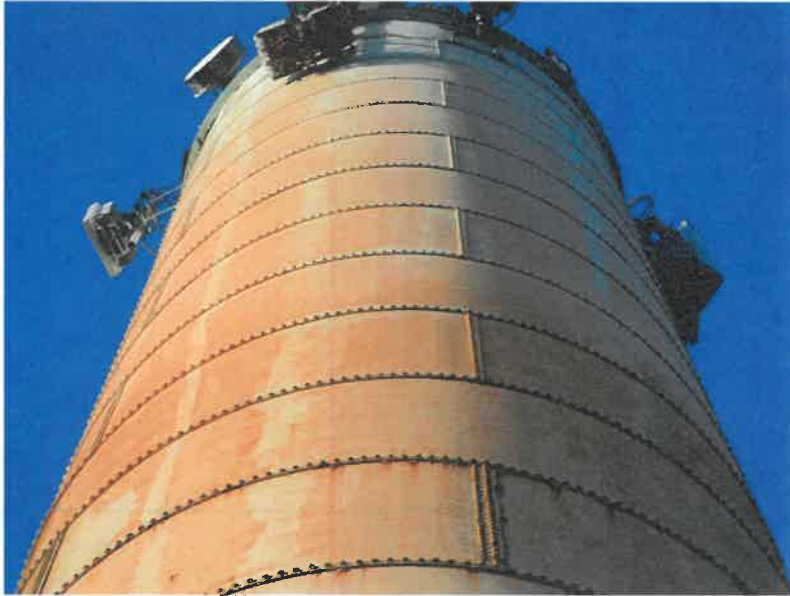
Photo # 27

Coating on shell.

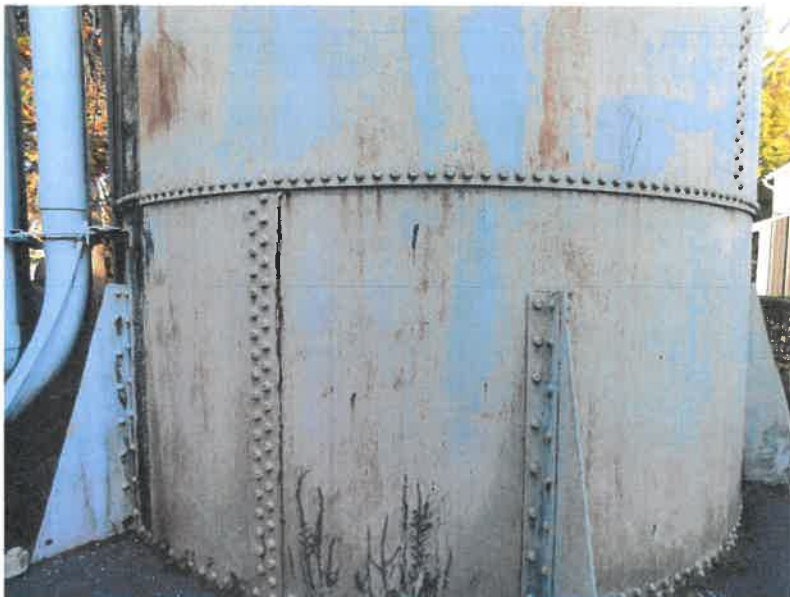
Photo # 28

Coating on shell.

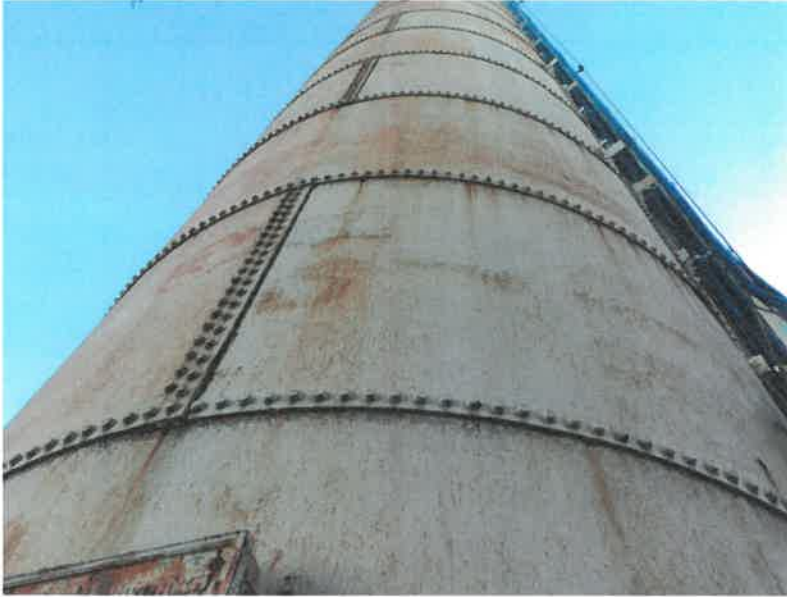
Photo # 31

Coating on shell.

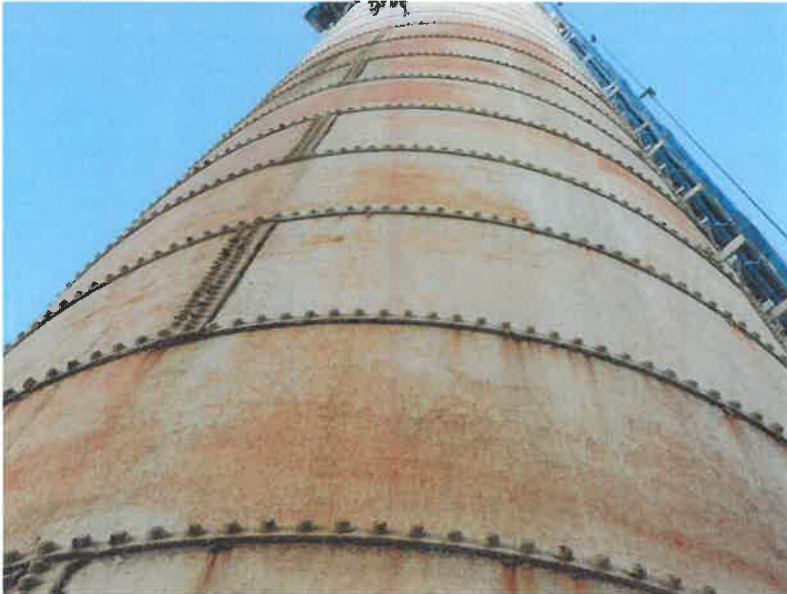
Photo # 32

Coating on shell.

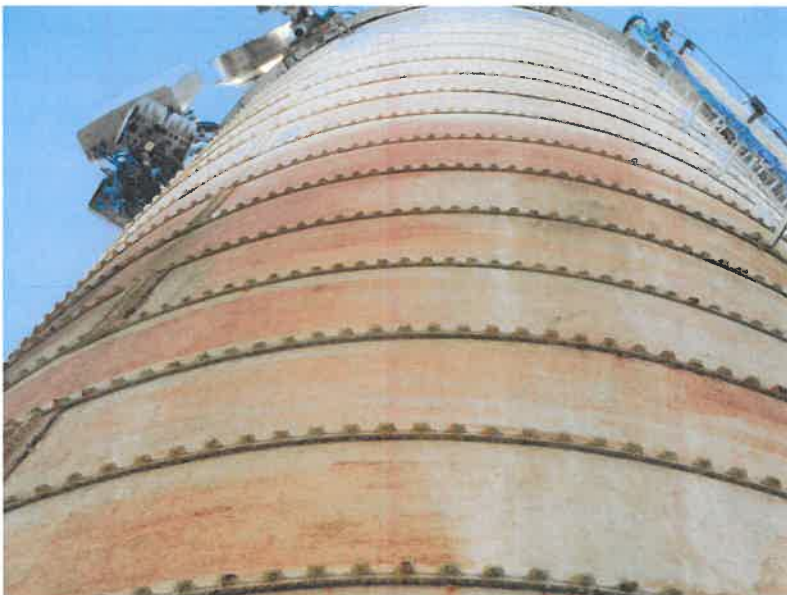
Photo # 33

Coating on shell.

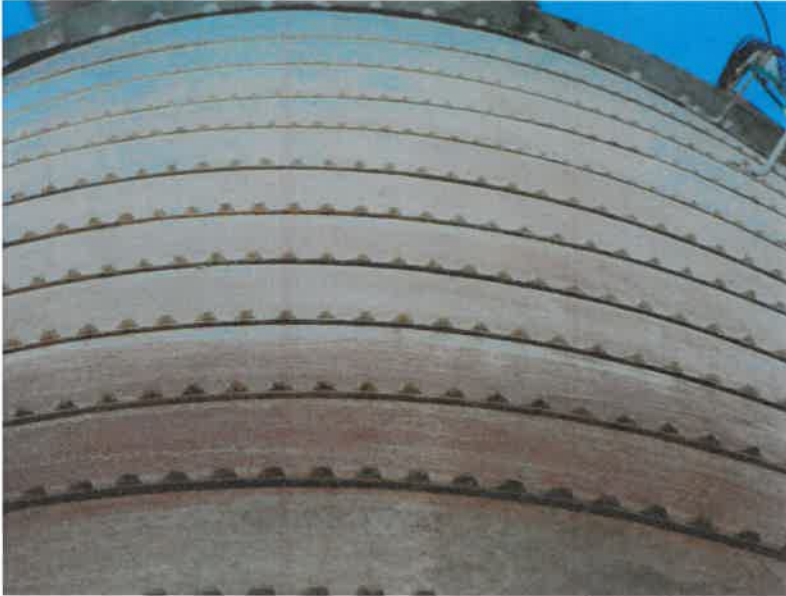
Photo # 34

Coating on shell.

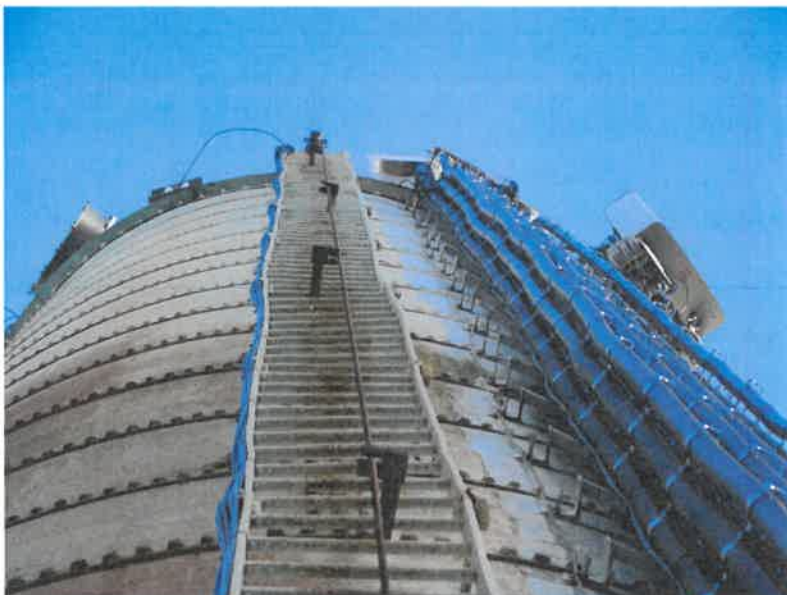
Photo # 39

12" CRW shell ladder with flexible cable safety climb, and posted signage.

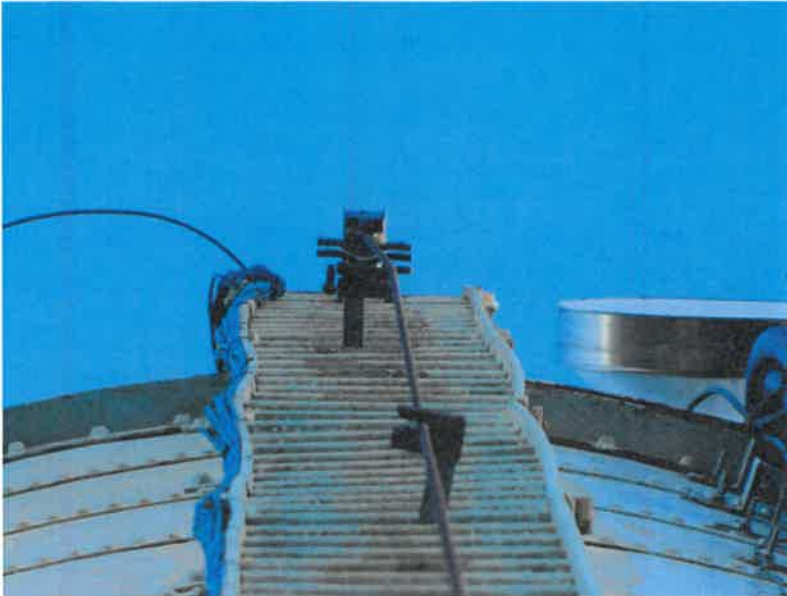
Photo # 40

12" CRW shell ladder with flexible cable safety climb, and T-Mobile coaxial cable run.

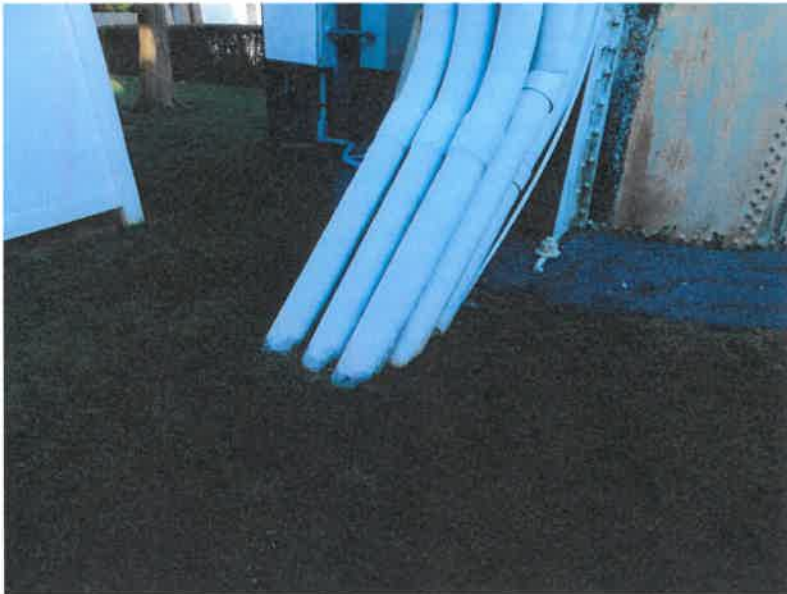
Photo # 41

12" CRW shell ladder with flexible cable safety climb.

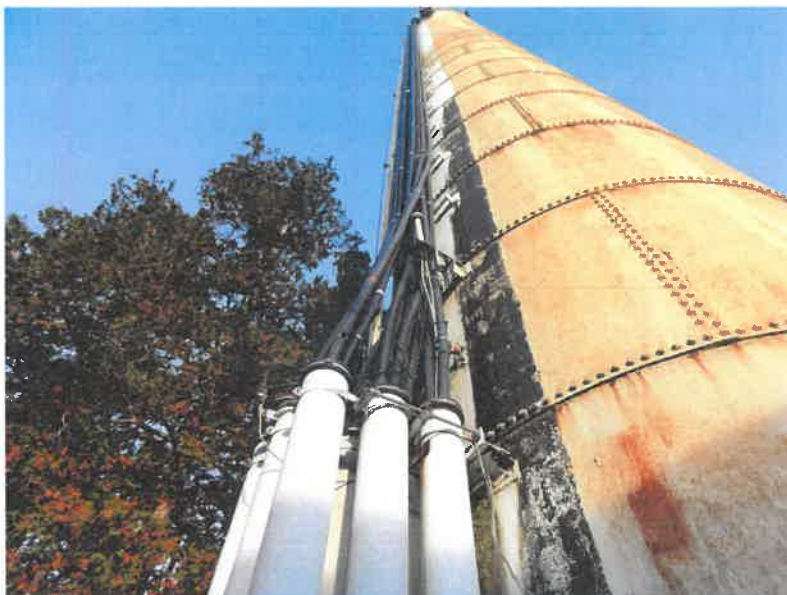
Photo # 42

T-Mobile coaxial cables.

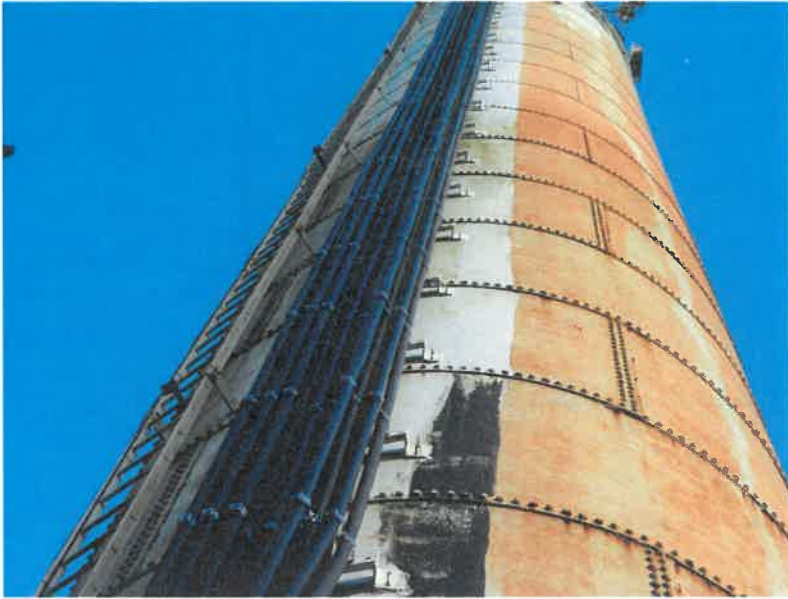
Photo #43

T-Mobile coaxial cable rung up shell.

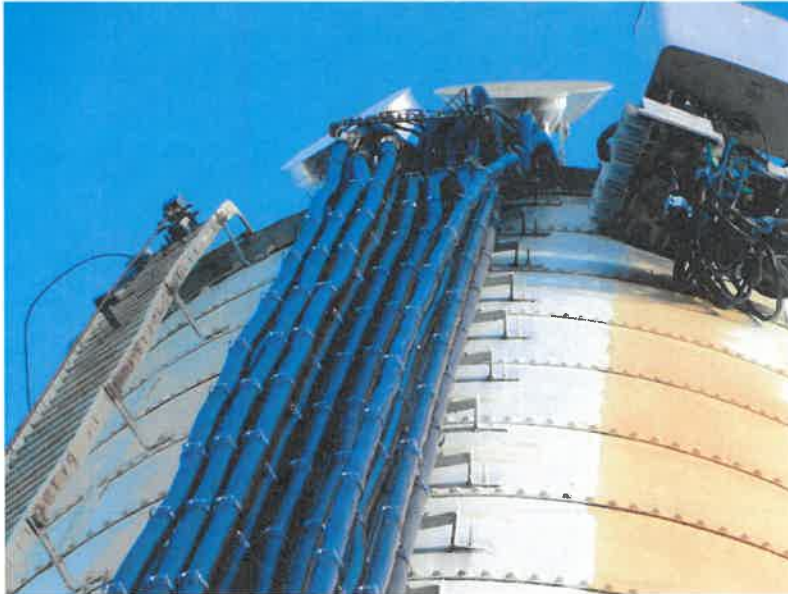
Photo #44

T-Mobile coaxial cable rung up shell.

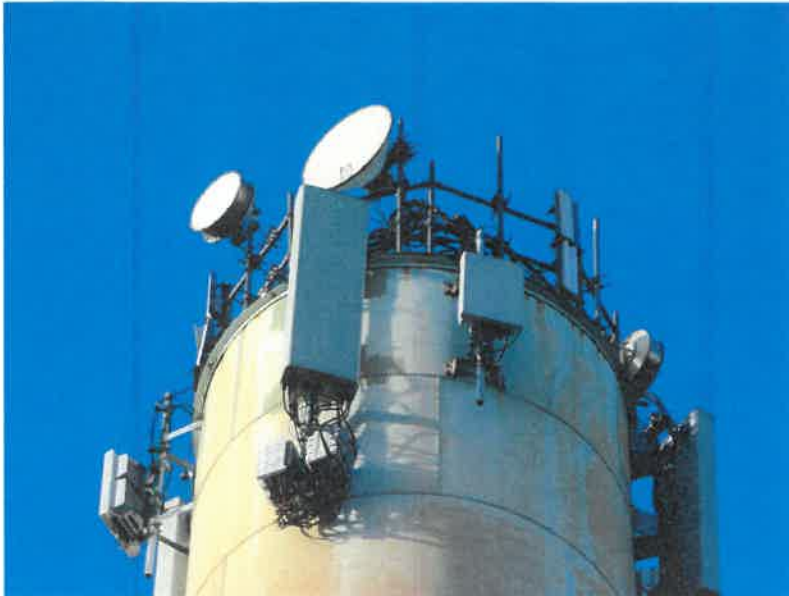
Photo # 46

T-Mobile antennas on shell, internet dishes on roof.

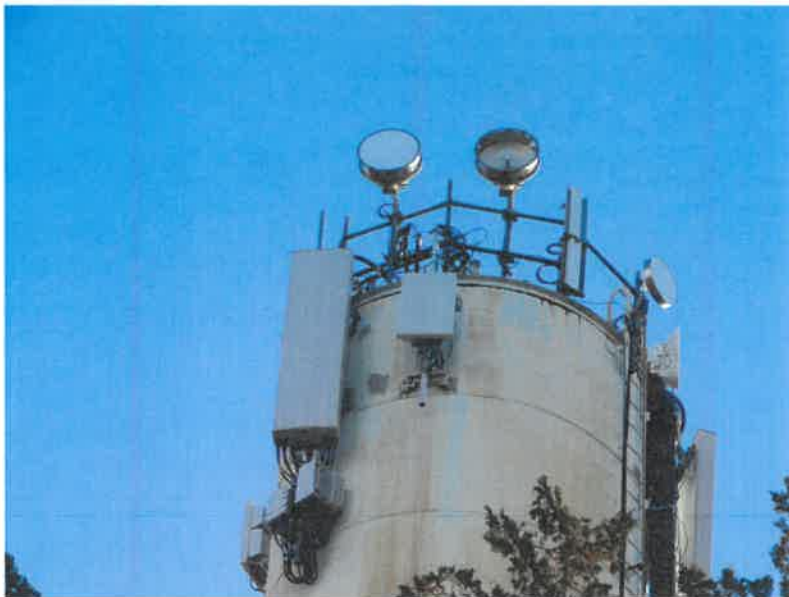
Photo # 47

T-Mobile antennas on shell, internet dishes on roof.

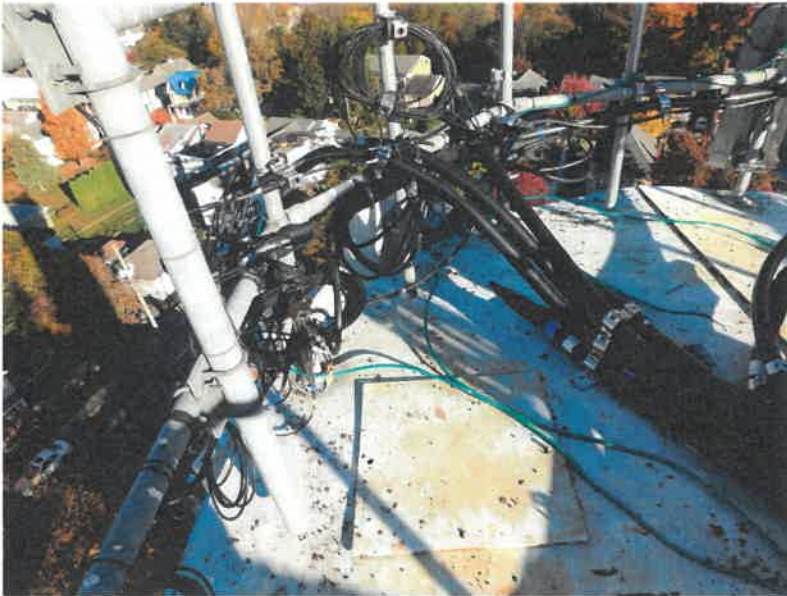
Photo # 50

Coaxial cables and coating on roof.

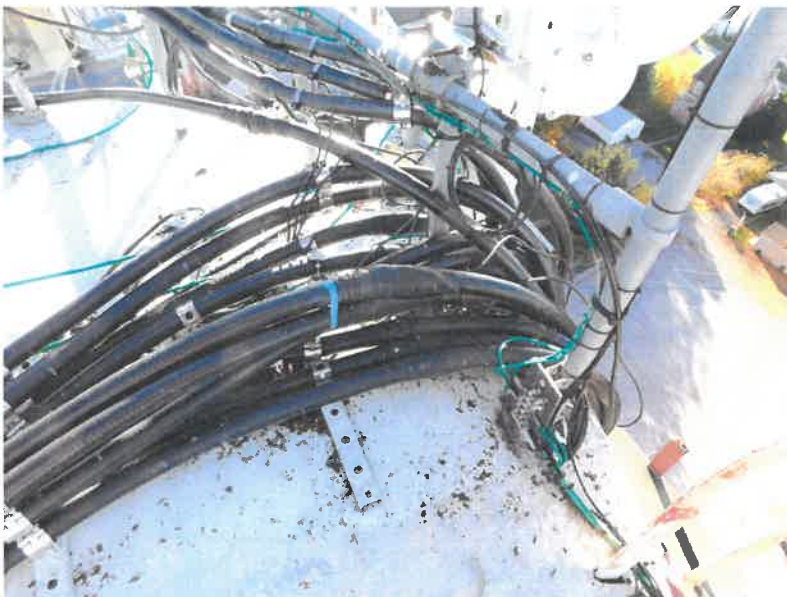
Photo # 51

Coaxial cables and coating on roof.

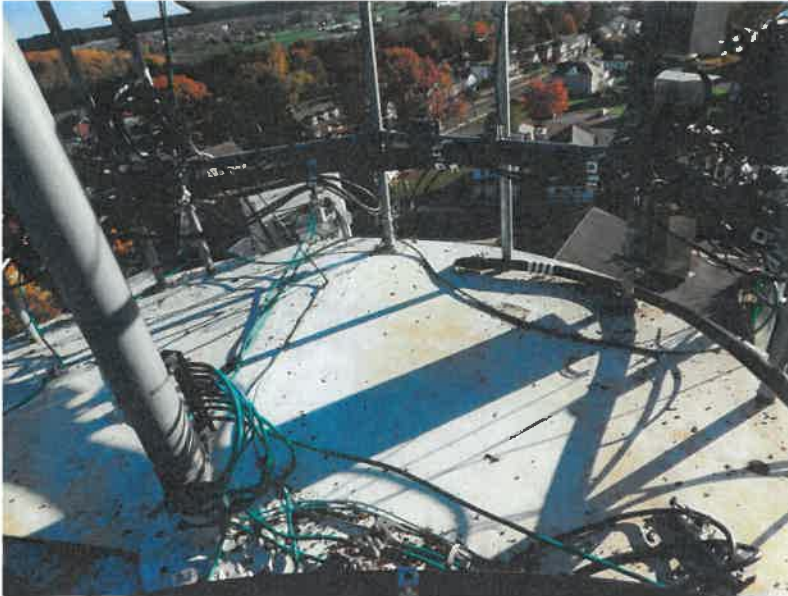
Photo # 52

Coaxial cables at roof transition.

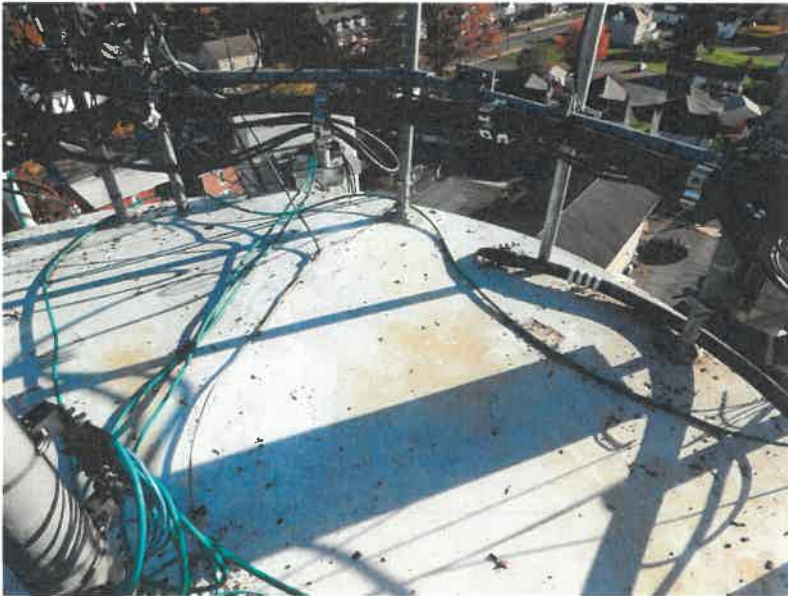
Photo # 53

Coaxial cables and coating on roof.

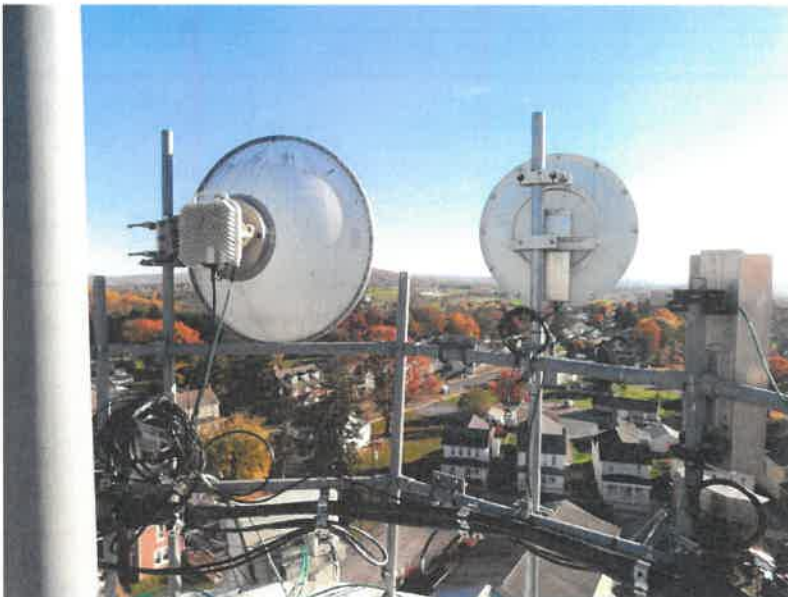
Photo # 54

Coating on roof.

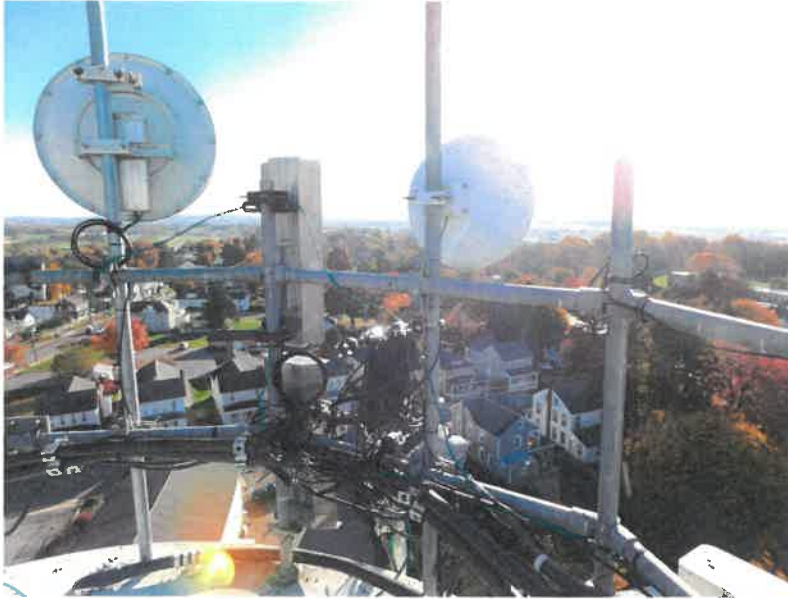
Photo # 55

Internet provider dishes, panel antenna, and supporting pipe array on roof.

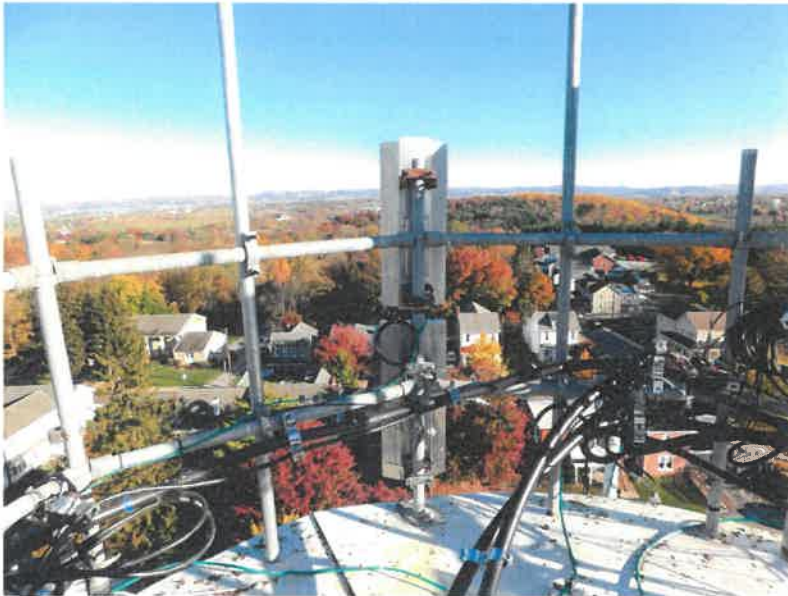
Photo # 56

Internet provider dishes, panel antenna, and supporting pipe array on roof.

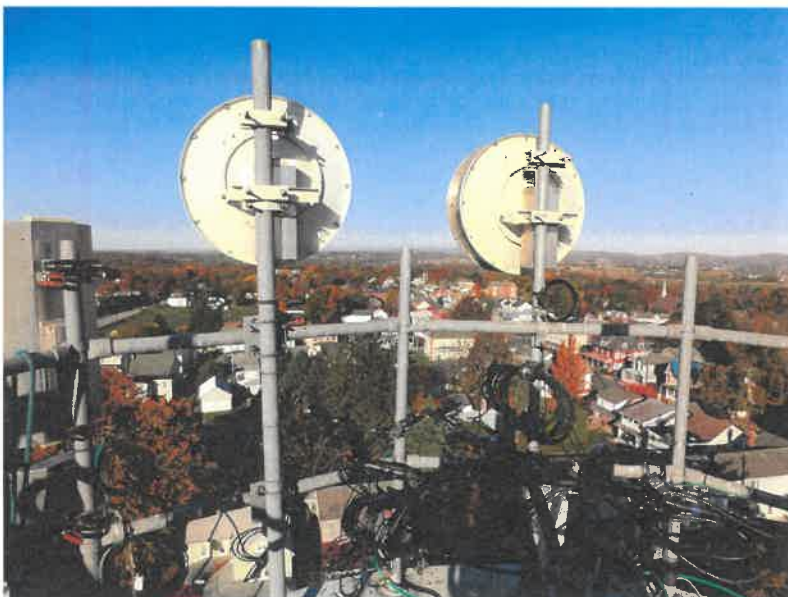
Photo # 57

Internet provider panel antenna and supporting pipe array on roof.

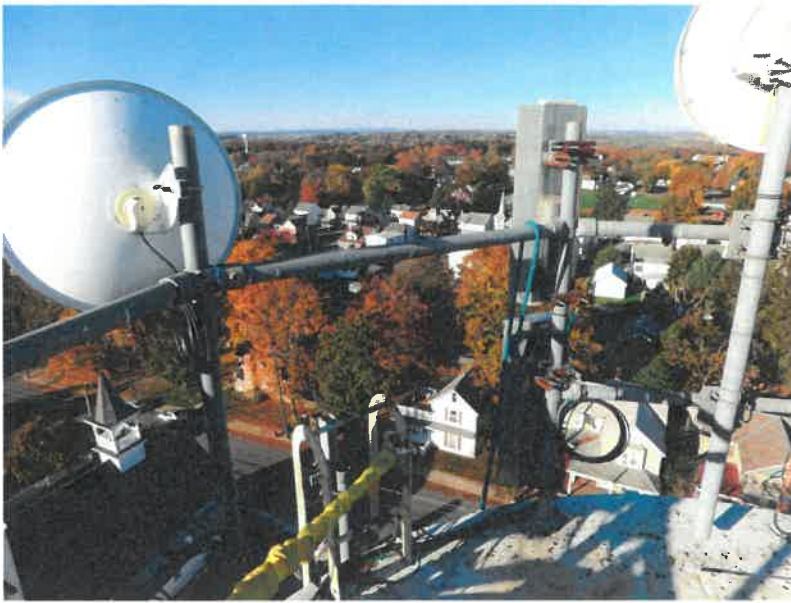
Photo # 58

Internet provider dishes, panel antenna, and supporting pipe array on roof.

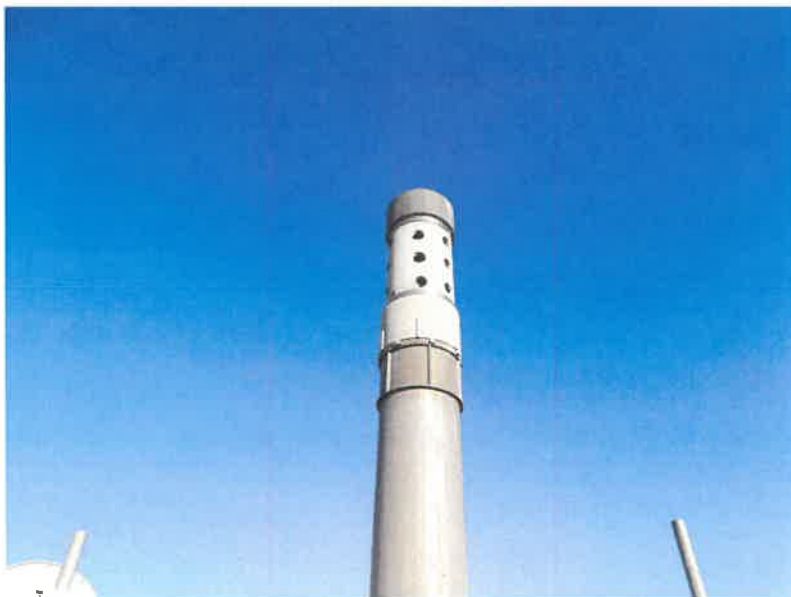
Photo # 60

f. Roof Vent - A 4" diameter carbon steel to PVC roof vent is present at the center roof. Drilled holes are present at the top of the PVC but no screen was present. See photographs #59-#61.

4" diameter center roof vent transitions from steel of PVC pipe.

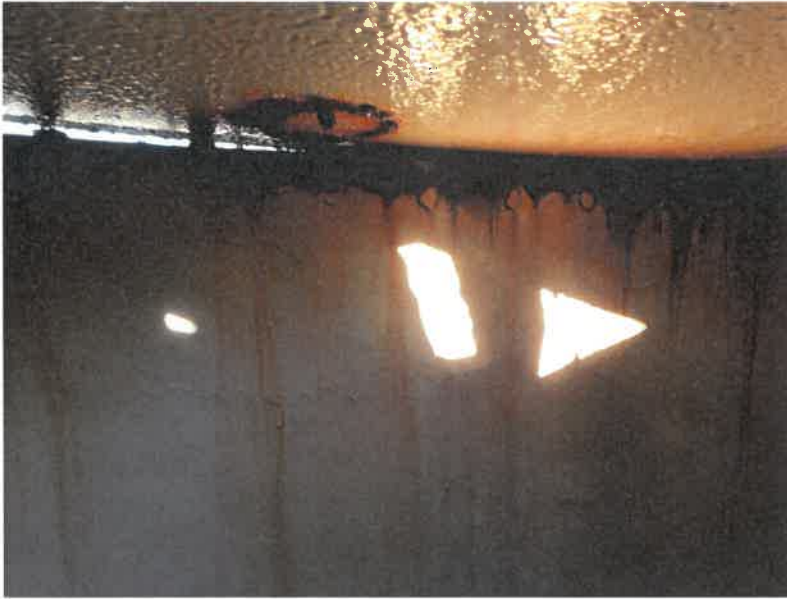
Photo # 67

Coating on interior roof, shell, and rafters.

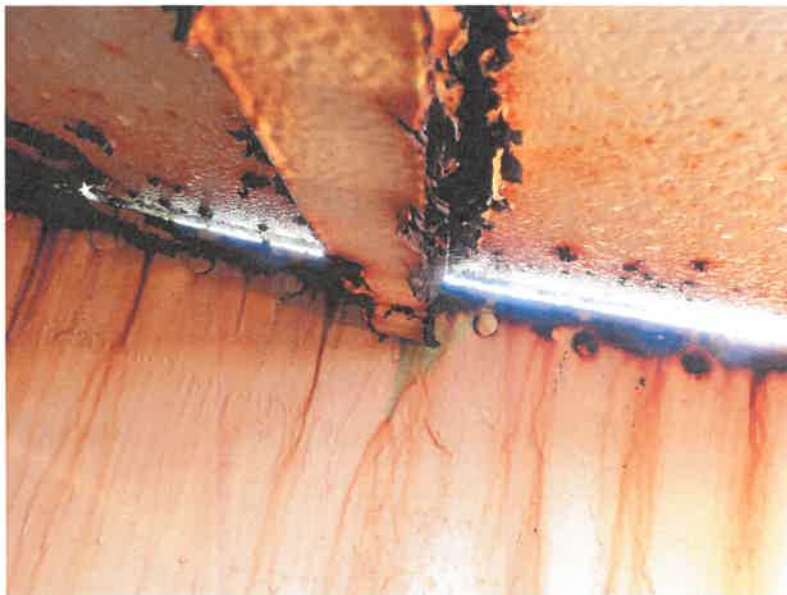
Photo # 69

Coating on interior shell and roof. Note: Gap at interface.

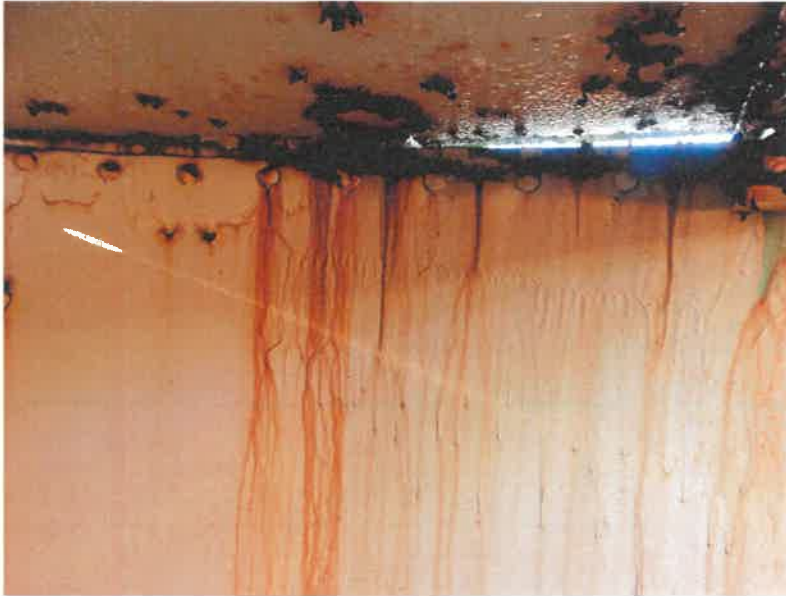
Photo # 70

Coating on interior shell, rafter, and roof. Note: Gap at interface.

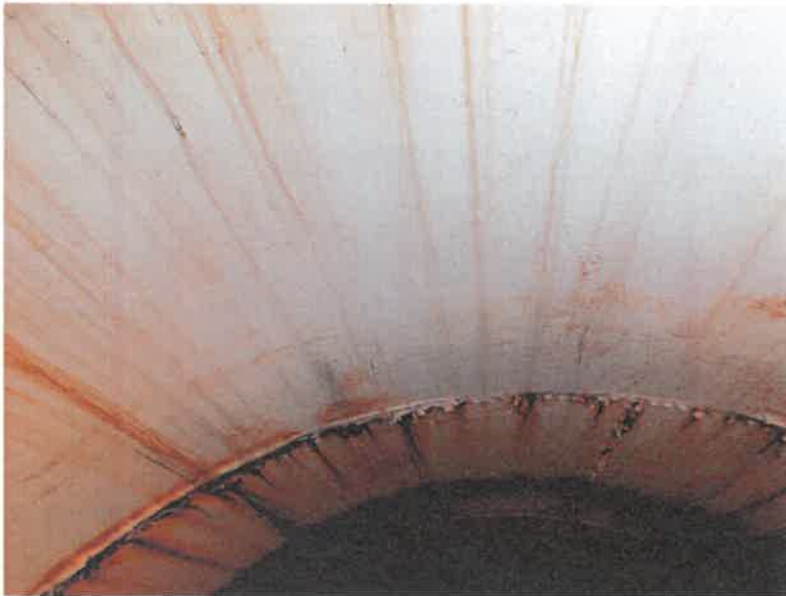
Photo # 71

Coating on interior shell and roof. Note: Gap at interface.

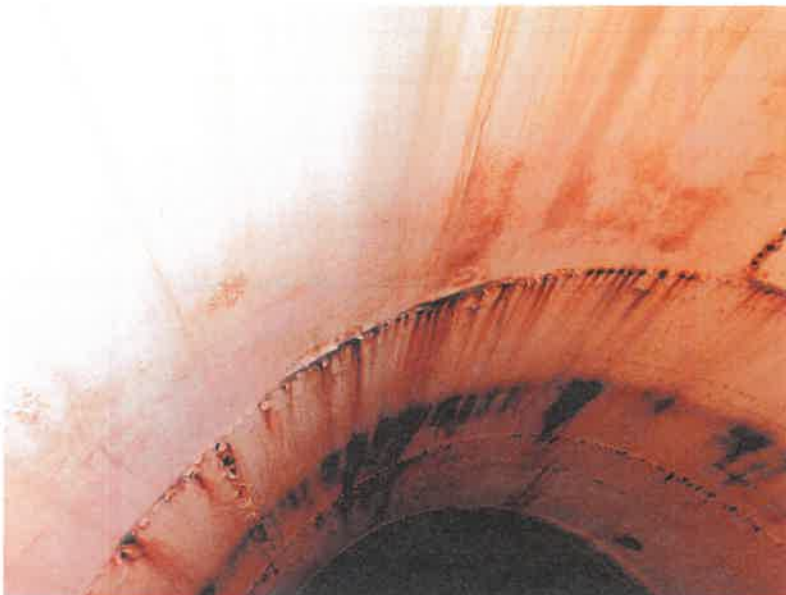
Photo # 72

Coating on shell.
